**SECTION 1: PREPARING THE VEHICLE TUB AND BED LINERS –REMOVAL OF SPORTS BARS & BED LINERS AND SEALING THE TUB.**

**SECTION 1A: REMOVING THE CENTRE HIGH MOUNTED STOP LIGHT ON FORD RANGER XL-XLS MODELS**

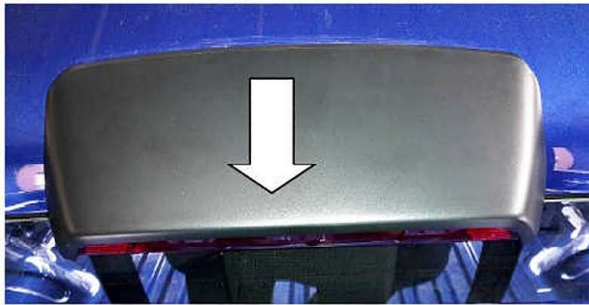
1.4) Remove the CHMSL Cover by pulling the cover towards the rear of the vehicle.

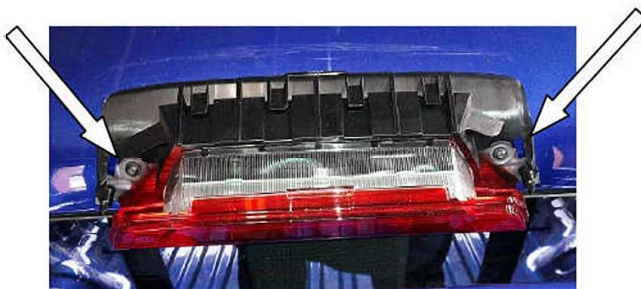
1.5) Using a T15 torx key, unscrew the two retaining screws and remove the light housing (Retain the two screws as they will be required later for retaining the cover)

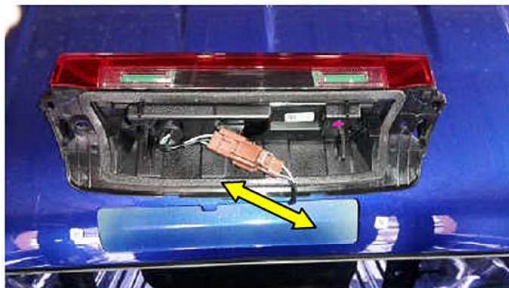
1.6) Unclip the light from the loom and remove, using masking tape securely tape the remaining wiring loom inside the cavity ensuring it cannot rattle.

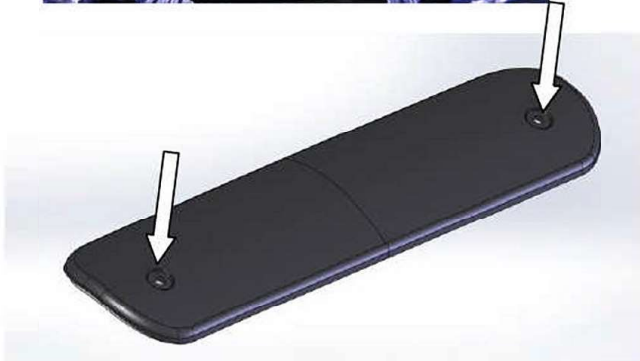
1.7) Ensure the foam tape seals are correctly fitted around the edge perimeter of the covers inside surface and the sealing disc pads are over the screw holes on the inside. Carefully pierce the foam sealing discs through the holes in the cover with a sharp point such as a nail
